Supplemental Figure 1 – Ebola Treatment Center, Makeni Sierra Leone

Supplemental Figure 2 – The MultiSense™ patch

Supplemental Figure 3 – Components of the Modular Wireless Patient Monitoring System (MWPMS) transported in the pictured suitcase.

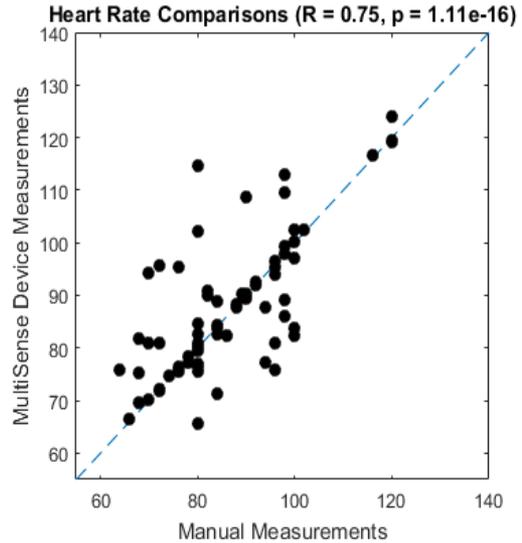
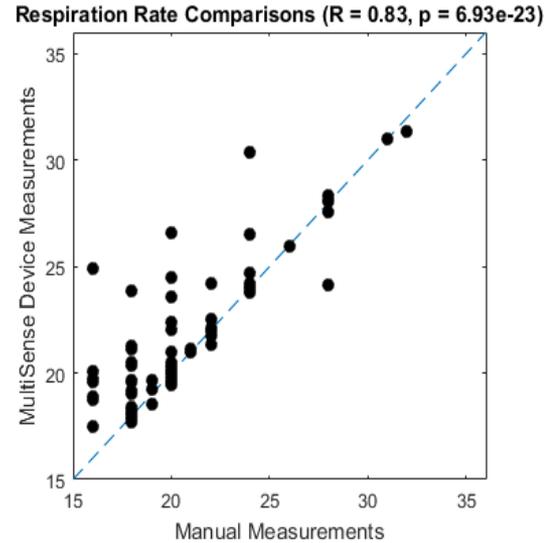
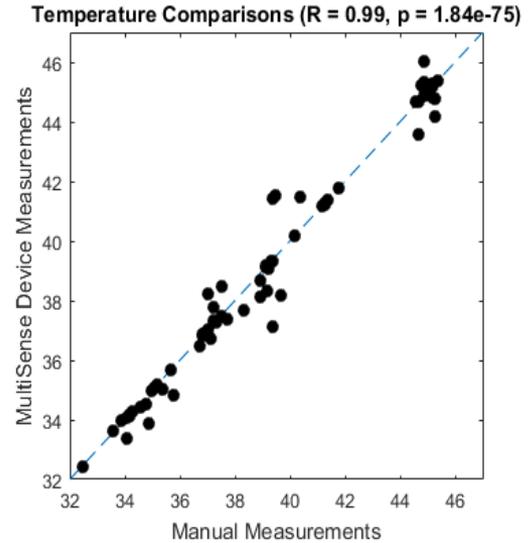
Supplemental Figure 5

Supplemental Figure 6 – Correlation between Medical team member-measured vital signs and near-simultaneous MultiSense patch measured value.
